Manhole Inspection Summary

Manhole # S15QQ_004MH

Location Address: **BEHIND 3117 FAIRVIEW AVE**

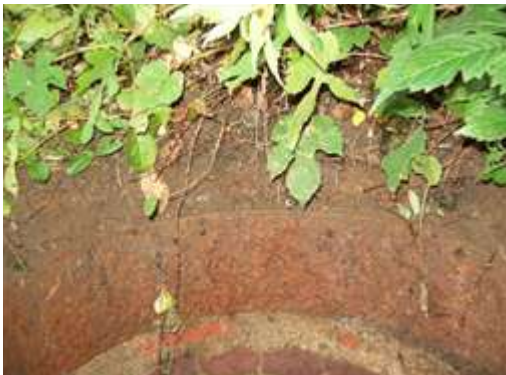
Subject To Ponding: **Sheeting**

SHEETING

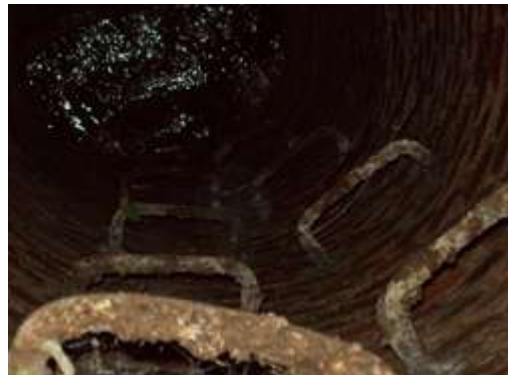
Defect 7

Steps Count: **16** Missing: **0** ☒ **Corroded**

Corroded steps

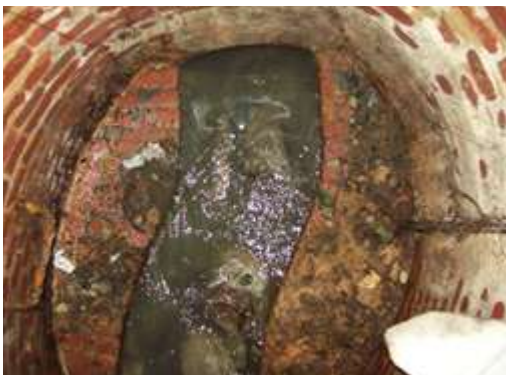
Defect 6

Surcharge ☒ **Evidence Of Surcharge** Depth: **1** (ft.) ☐ Active Surcharge Present

EVIDENCE OF SURCHARGE ON
BENCH

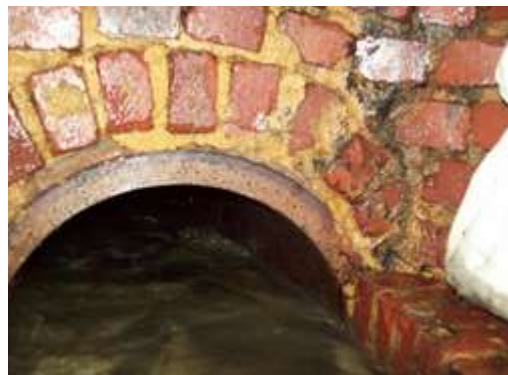
Defect 5

Condition: ☐ Sound ☐ Cracked ☒ **Root Intrusion** ☐ Loose Brick ☒ **Deteriorated**

DETERIORATION OF BARREL WALL

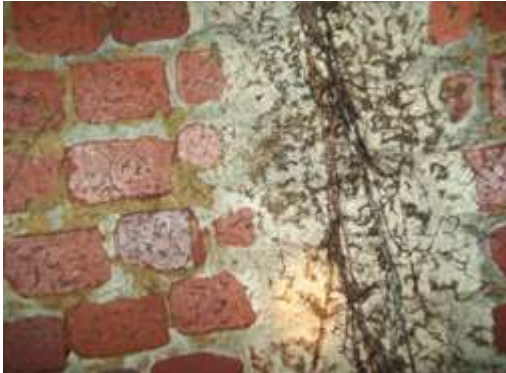
Defect 3

ROOT INTRUSION BARREL WALL

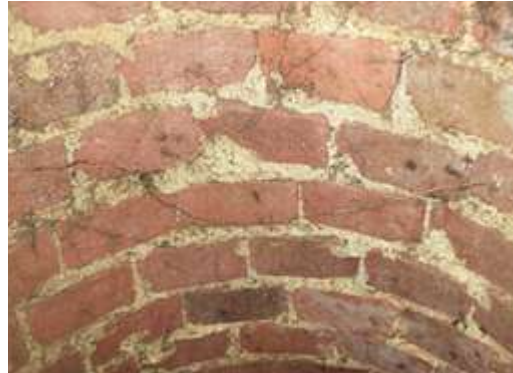
Defect 1

Condition: ☐ Sound ☐ Cracked ☒ **Root Intrusion** ☐ Loose Brick ☐ Deteriorated

FINE ROOT INTRUSION IN CORBEL

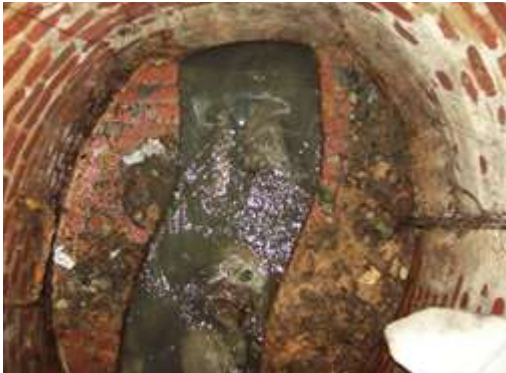
Defect 4

Condition: ☐ Sound ☐ Cracked ☐ Root Intrusion ☐ Deteriorated ☐ Leaks ☒ **Debris**

DEBRIS IN CHANNEL AND ON BENCH

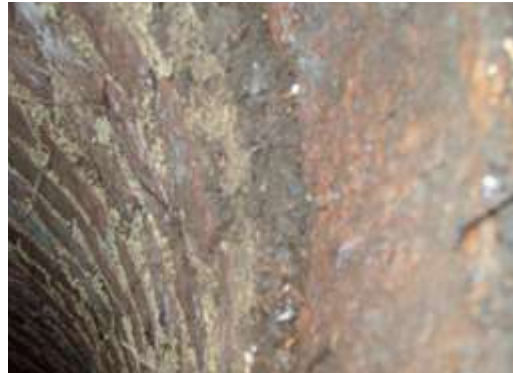
Defect 2

Frame Offset: **1** (in.) Condition: ☒ Sound ☐ Cracked ☐ Leaks

FRAME OFFSET 1"

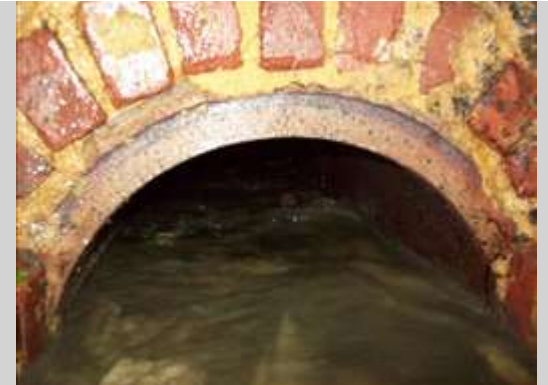
12 O'Clock Outflow

Pipe Height: (in.) Direct
Pipe Material: **Clay** ☐ Pipe Lined
Invert Depth: **27.29** (ft.) Flow Characteristics: **Slow**
Deposits: ☐ None ☐ Mud ☒ **Sludge** ☐ Debris ☐ Grease
Silt Depth: **5** (in.) Deposits Extent: **Medium**
Infiltration: **None** Pipe Seal Cond: **Sound**

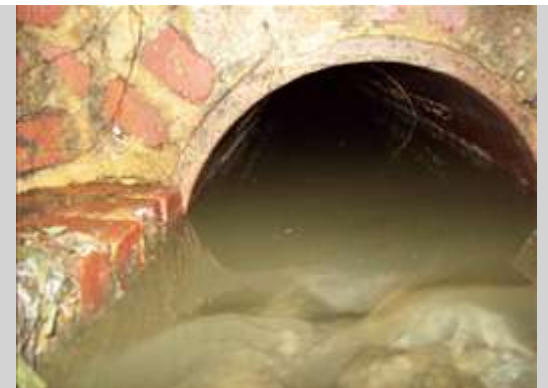
6 O'Clock Inflow

Pipe Height: (in.) Direct
Pipe Material: **Clay** ☐ Pipe Lined
Invert Depth: **27.16** (ft.) Flow Characteristics: **Slow**
Deposits: ☐ None ☐ Mud ☒ **Sludge** ☒ **Debris** ☐ Grease
Silt Depth: **5** (in.) Deposits Extent: **Medium**
Infiltration: **None** Pipe Seal Cond: **Sound**
